THE **Indian** MOTORCYCLE COMPANY

Bulletin No. SVB-119

Model SE-74

ELECTRICAL PROBLEMS ON THE SE-74 (Blowing Headlights at High Engine RPM)

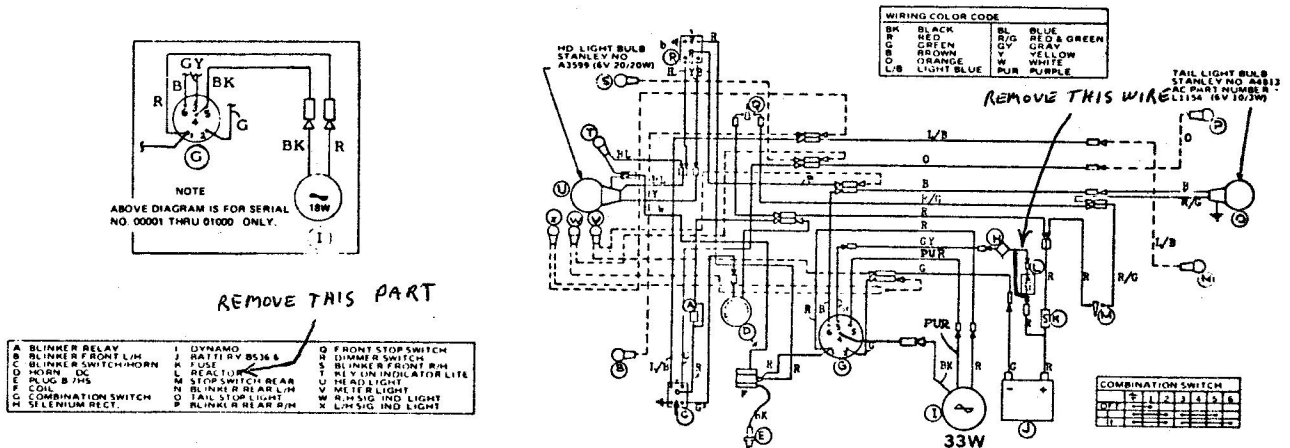
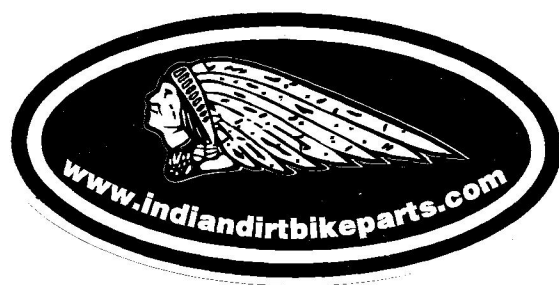
This will eliminate the high voltage going directly to the lightbulbs.

To eliminate the lightbulb blowing at high RMP, disconnect the two gray wires from the reactor (Item No. L). Connect the one gray wire from the selenium rectifier (Item No. H) directly to the gray wire that comes out of the main ignition switch harness.

Refer to the below drawing showing the changes in Items H and L.
