SERVICE BULLETIN

Bulletin No. SVB-122

Model SE-74

Subject High-Low Beam
Switch Modification

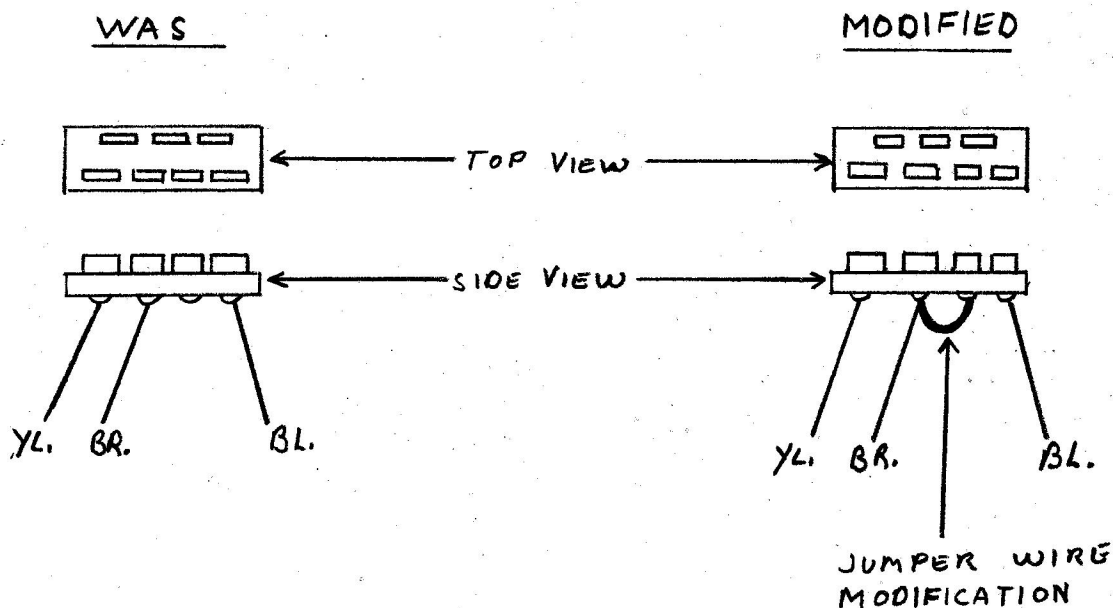
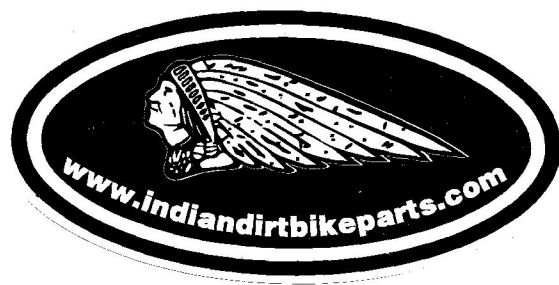
To eliminate the headlight and taillight blowing at high engine speed the previous Service Bulletin #119 must be performed. This eliminates the reactor from the electrical system.

The high-low beam switch assembly must be disassembled and the inside contactors of the high-low beam switch must be soldered together as the drawing below.
